# ANCHORAGE SCHOOL DISTRICT

## REQUEST FOR PROPOSAL

Show the following on the outside of the sealed proposal envelope:  
**RFP 2026-612 PROFESSIONAL SERVICES CP&C AND M&O TIER 2/3 SEISMIC EVALUATION**

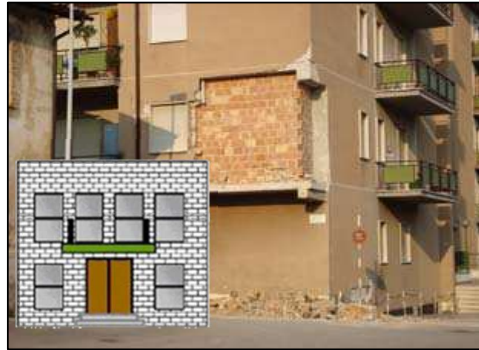
Figure 2: Immediate Occupancy (S-1) - Note damage to facade, but underlying structural brick in working condition.

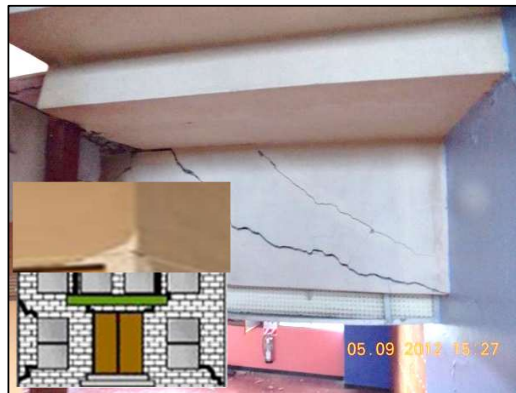
Figure 3: Life Safety (S-3) - Cracking/deflection in concrete beam, cannot be repaired.

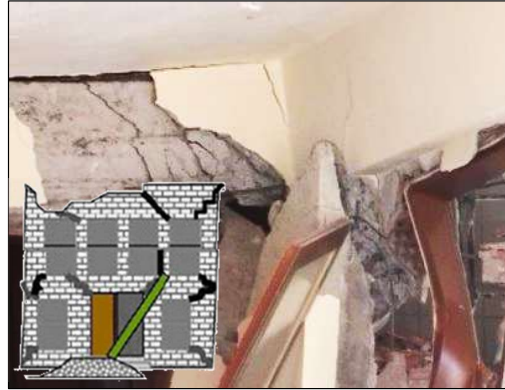
Figure 4: Collapse Prevention (S-5) - Severe buckling of members, near collapse.

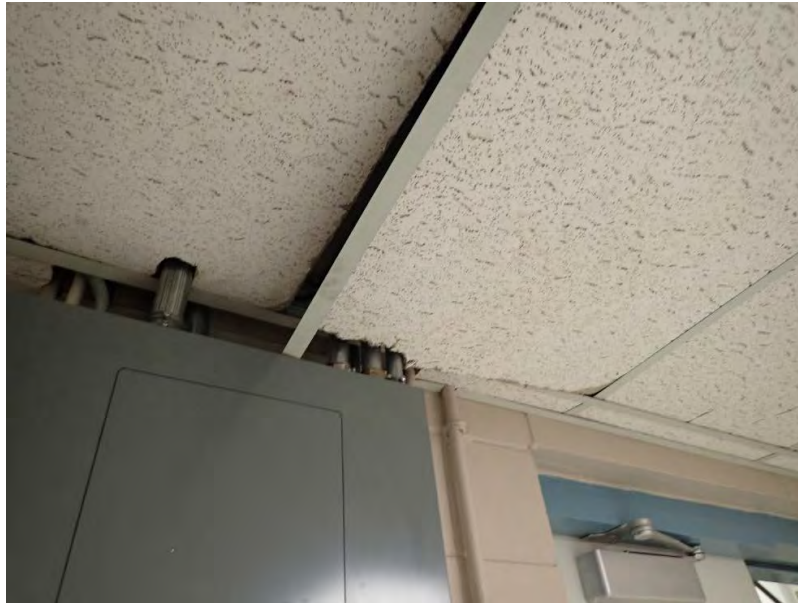
Corridor 150, Lack of Edge Clearance, Damage Figure B- 23

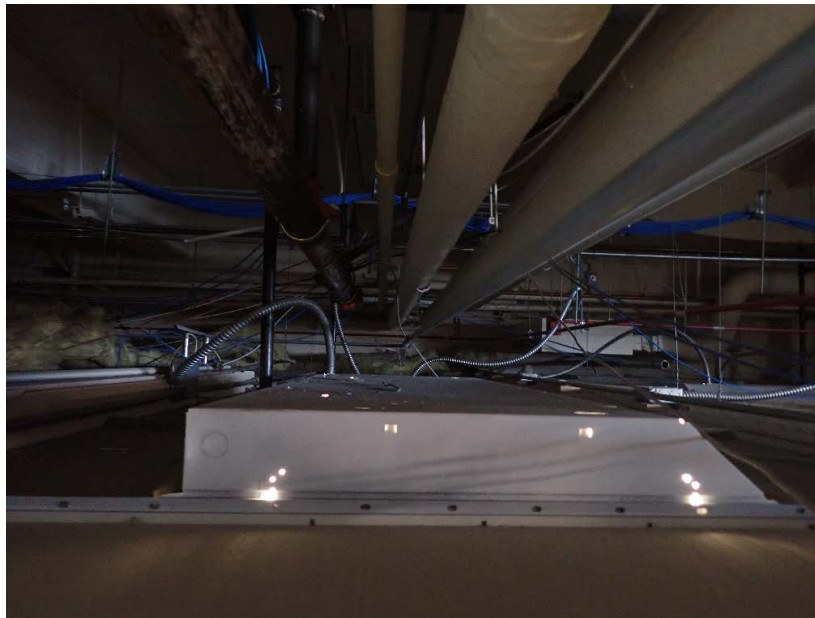
Corridor 150, Lack of Light Independent Support Figure B- 24

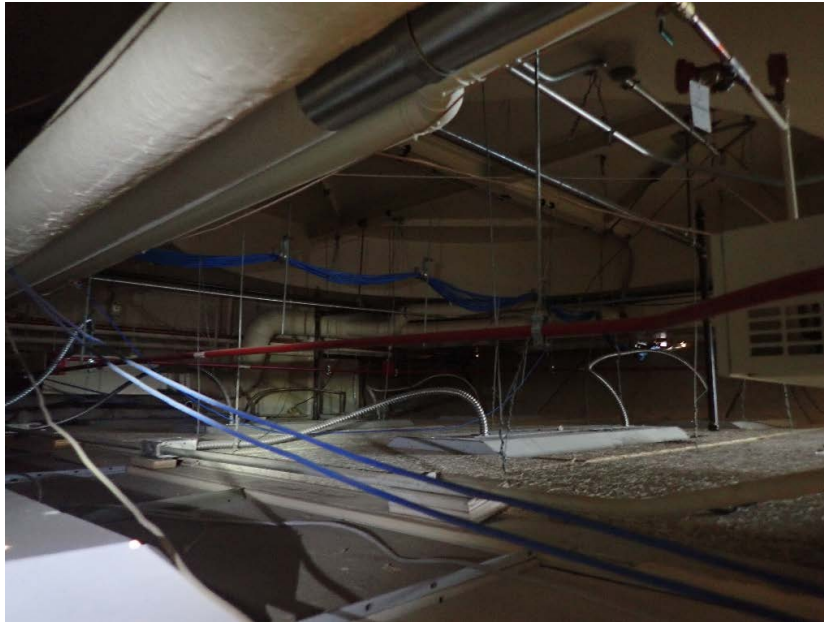
Corridor 150, Lack of Light Compression Strut Figure B- 25

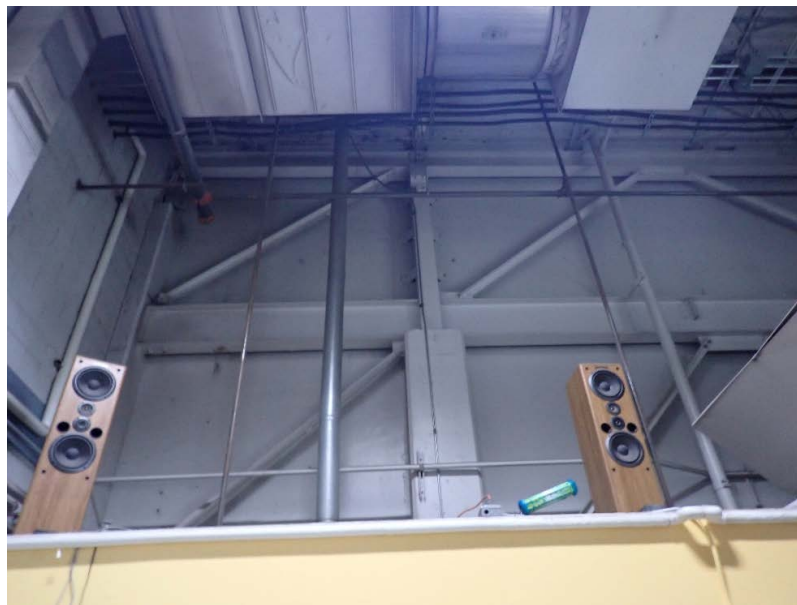
Paint Shop, Improperly Restrained Piping and Vent Figure B- 26

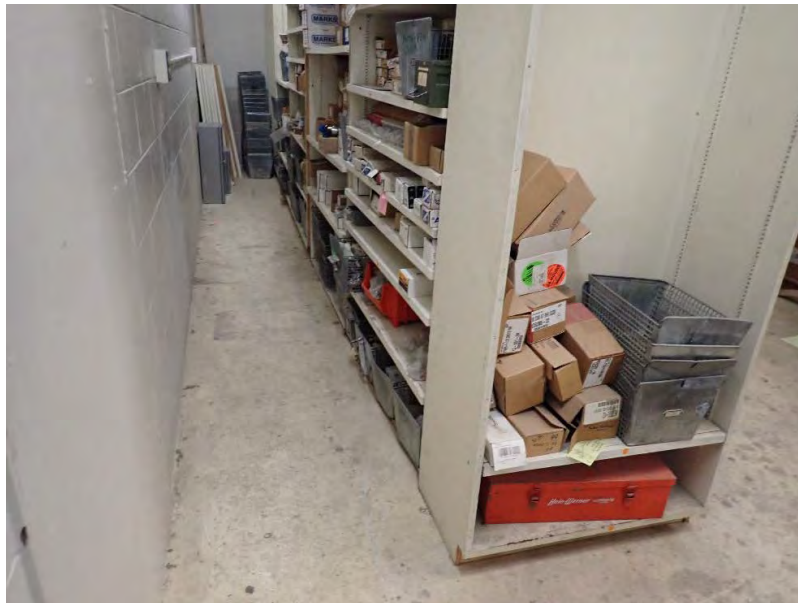
Door Shop, Unrestrained Shelves & Fall Prone Contents Figure B- 28

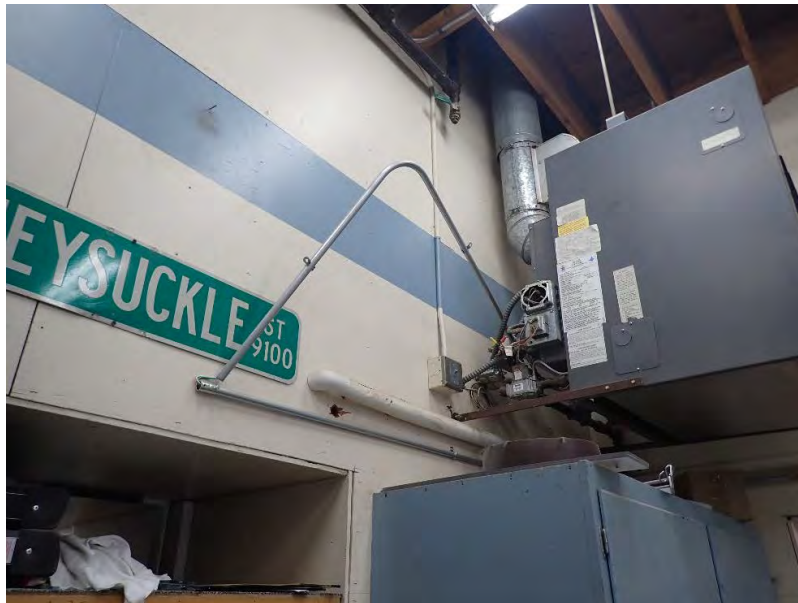
Glass Shop, Improperly Restrained Mechanical Unit

Conduit Detached from Wall

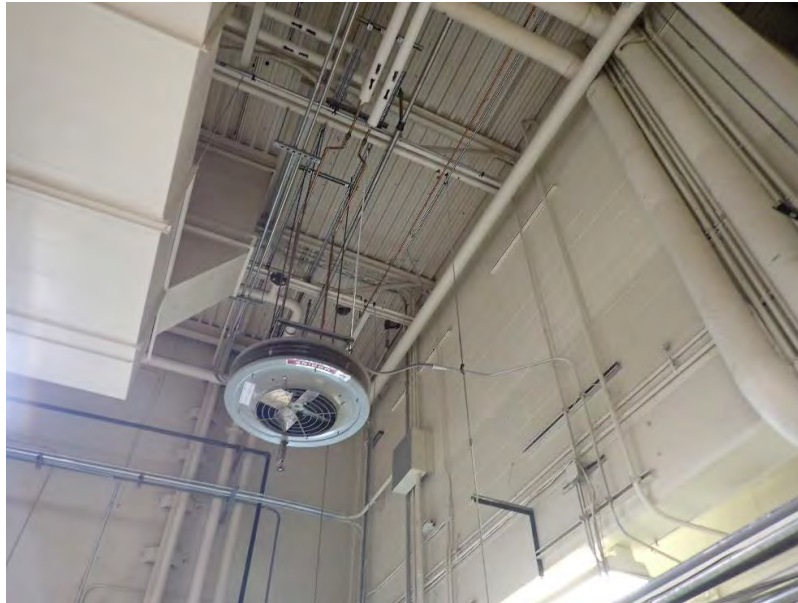
Room 105, Improperly Restrained Fan Figure B- 35

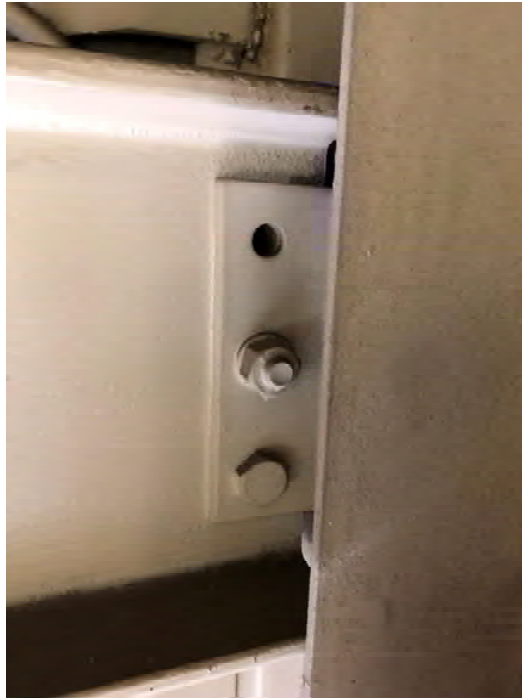
Vehicle Shop, South Bay Door, Header Missing Bolt Figure B- 47

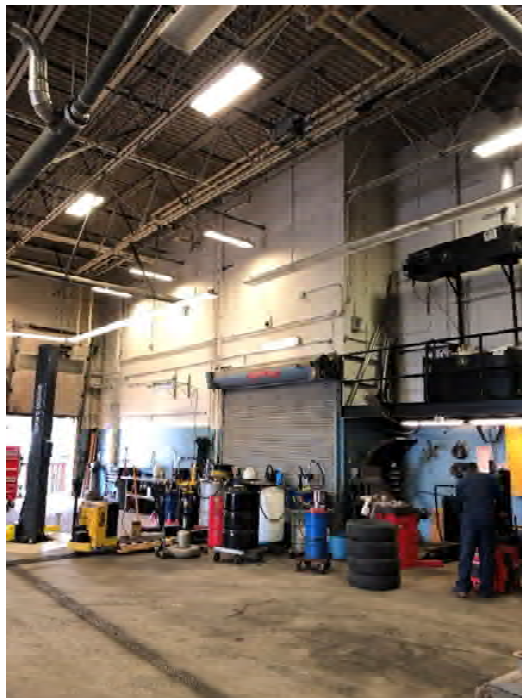
Vehicle Shop, Improperly Restrained Lighting Figure B- 48

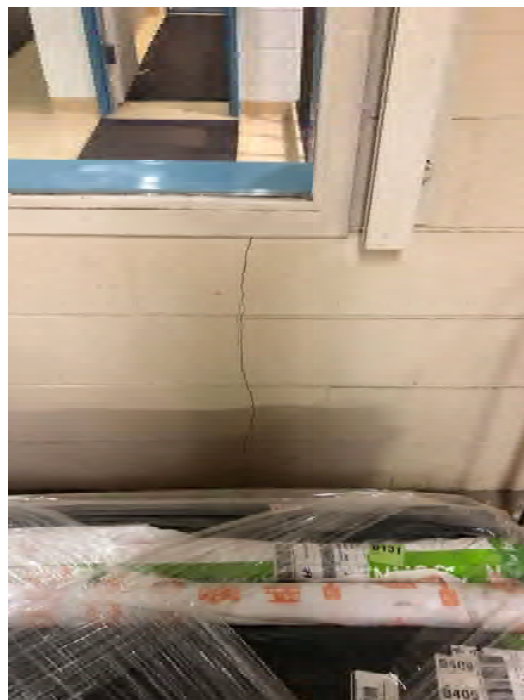
MCR Mezzanine 236, CMU Cracking Figure B- 62

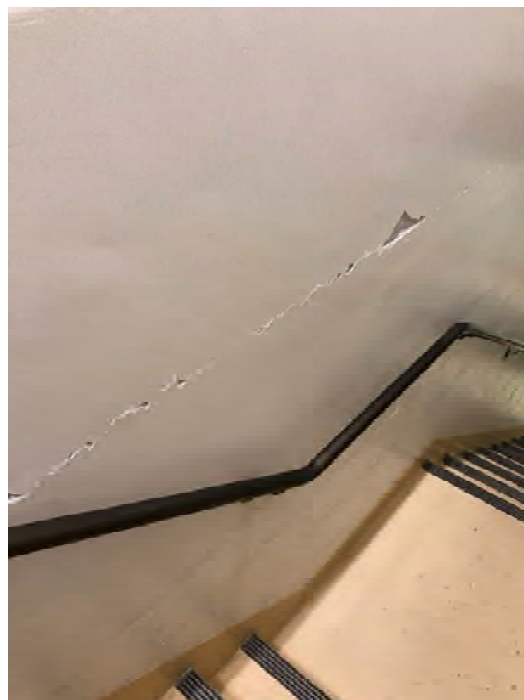
SW-3, CMU Cracking Figure B- 68

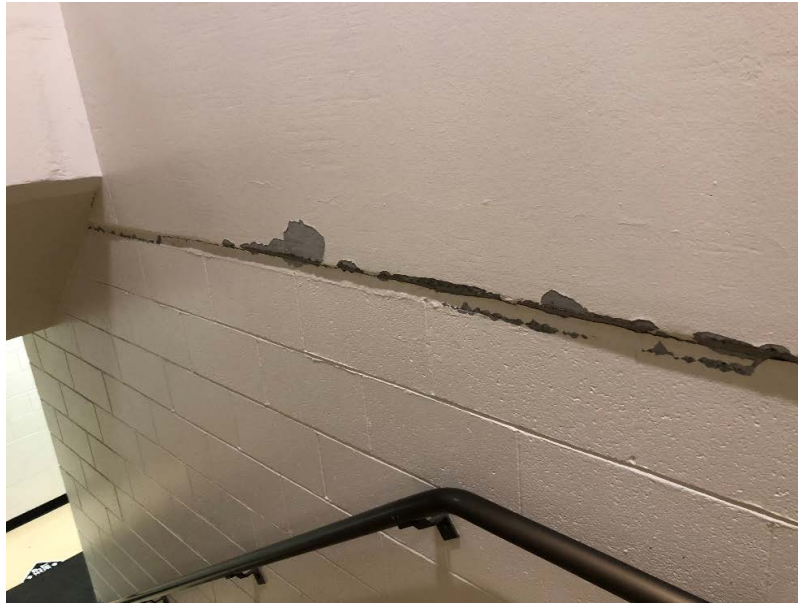
SW-3, CMU Cracking Figure B- 69

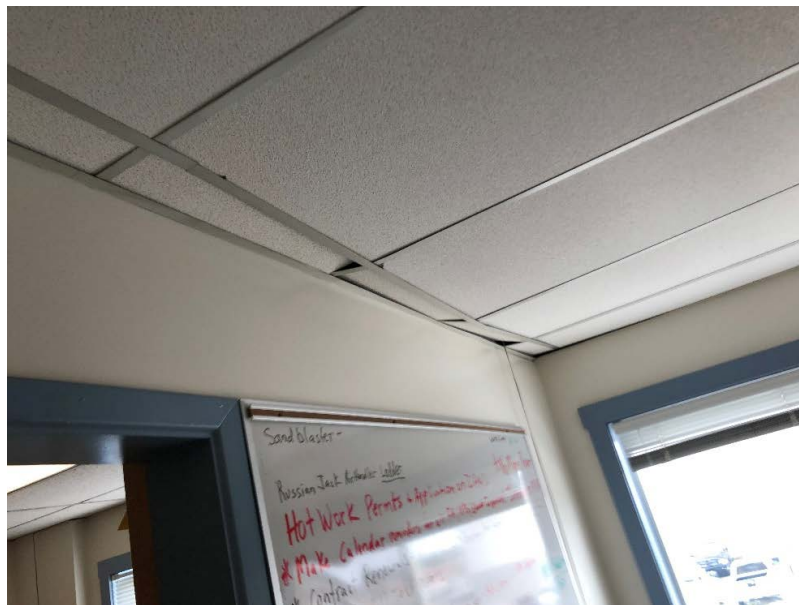
Regulation Room 242, Lack of Edge Clearance, Damage Figure B- 74

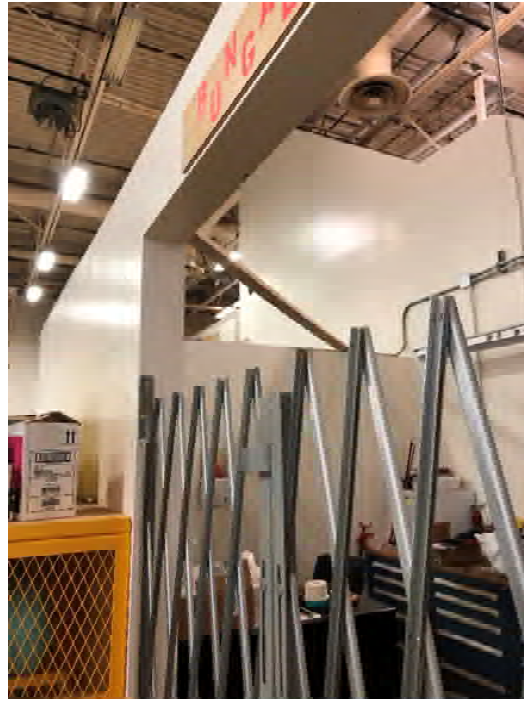
MCR Open Circulation, Partitions Improperly Restrained Figure B- 85
